About the damage of the penstock of Xekaman 3 hydropower plant due to sliding and the remedial measures for power generation

Bui Khoi Hung ^{*a}, Dao Manh Tung ^a

^a*Song Da consulting JSC, Ha Noi, Viet Nam*

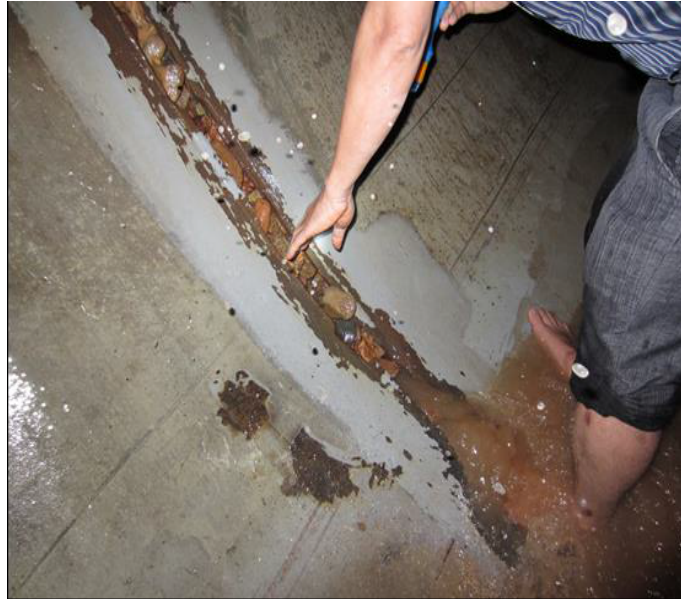
At present, the ancient landslide has reactivated and destroyed the penstock. After filling with water to prepare for electrical generation, at the chainage of km 6+384.56m where the penstock lies within the col-dQ deposits has been ruptured, the concrete lining and the steel lining has separated about 7cm. The water from the penstock has penetrated through the top layer of 70m thick of soil and rock

blocks due to hydraulic fracturing and sprayed to ground surface with discharge of about $30 \text{ m}^3/\text{s}$, forming a large sinkhole and a new stream.

Fig. 5. The first damage of penstock

At that time, the cause of these defects was attributed to the poor quality of the welding and concrete lining, so the remedial measure are rewelded and add additional steel for the penstock and add cement grouting around the penstock and filled the sinkhole. The power house has operated again, but during the rainy season a defect occurred at the chainage of km 6+ 396m within the colluvial- deluval deposits, far from previous breaking location, at welding point of a length of one steel tube. The concrete lining and the steel lining has been ruptured and has separated a distance of 4cm, causing a large discharge of water on the ground surface. At the separation location, it has been observed that the penstock has moved very slowly downstream, the distance growing from 4cm to 6cm. According the results of calculations, the col-dQ deposits (from the chainage km 6+384 to km 4+440m) has a low modulus of deformation (21 MPa), so during the operation process of penstock under high pressure is subjected to a longitudinal stress $\sigma_z = 350.8$ MPa, while the allowable stress of a steel tube is only 429 MPa. Surrounding the outer interval of the

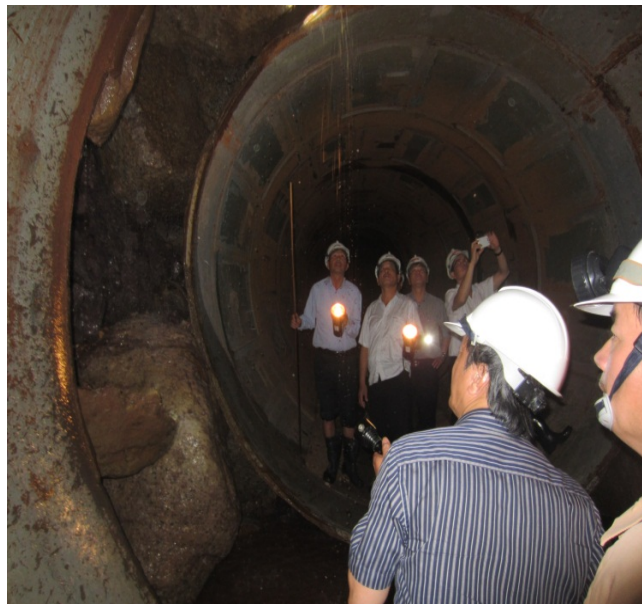
Fig.6. The second damage of penstock

penstock is sandstone and siltstone of zone MW having a modulus of deformation of 1000MPa, so the longitudinal stress of penstock is much smaller. Therefore when the landslide happened, the penstock was pulled, increasing the longitudinal stress so that the penstock was ruptured within the area of the col-dQ deposits and at the weakest location such (the welding point).

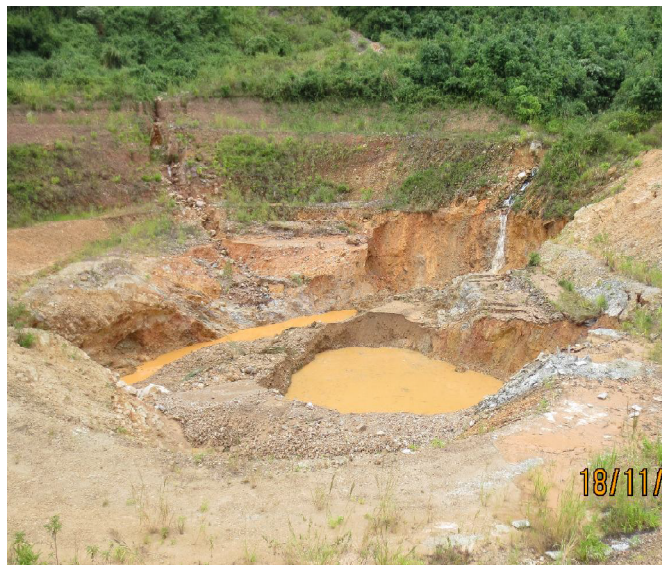
Fig.7. The sink pit

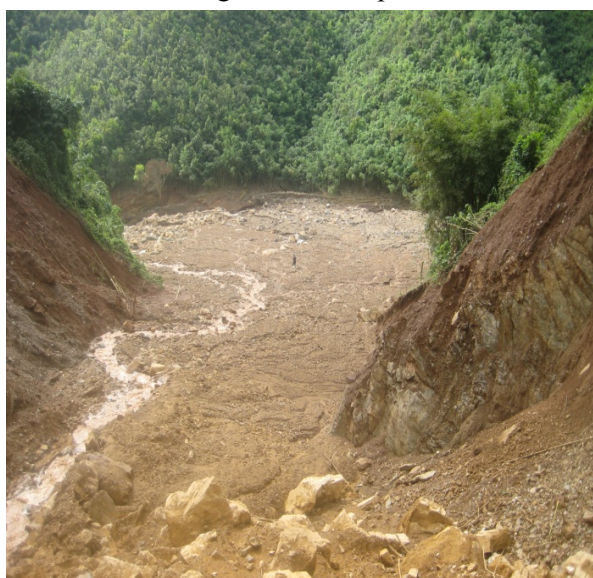
Fig.8. The new stream has been formed

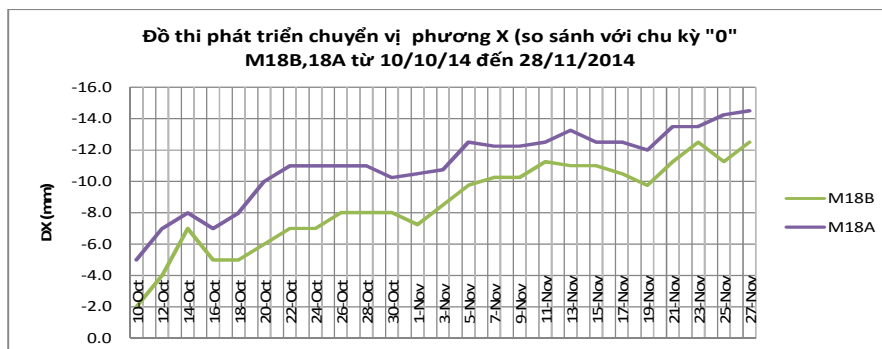
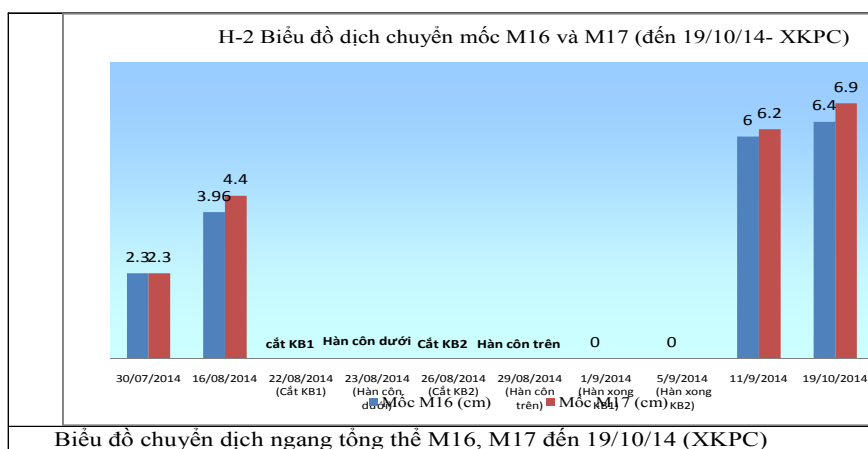
- Three points M16, M17 and M18 on the open penstock, from December 2013 to March 3-2014 (the end of rainy season to beginning of dry season), they had displacements of 22mm, 23mm and 27mm, averaging 10mm/month. During the dry season from March 3 to July 30-2014 they had a smaller displacement, being 3-5mm, averaging 1-2mm/month. During the rainy season from July 30 to September 11-2014, they had a displacement of 35mm to 39mm, averaging 19mm/month. From September 11 to October 11 (the end of rainy season), they had an average displacement 10mm.
- The landslide displacements gradually increase from the sink hole to the vertical shaft N2 and then quickly decrease towards the powerhouse. This proves that behind the vertical shaft N2 is a passive block, against the movement of the landslide.- The inclinometer shows that the direction of landslide is towards the powerhouse.

Fig.9 The graphic of horizontal displacement of the control points M18, M18a, M16,M17

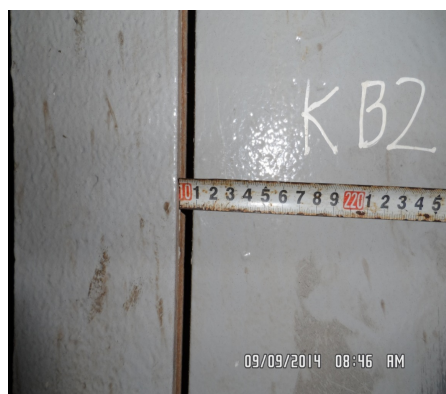
Fig.10. The compensator at the horizontal penstock

- In the interval from the zone of poor quality rock (zone HW and colloval- deluvial deposits) to the face G8, the steel tube has been placed into the 3,1m diameter horizontal penstock. This 2m diameter and 30mm thick steel tube has 2 compensators, so it can operates safely when the landslide is moving.
- The 3,1m diameter, concrete lining and steel lining vertical shaft, from the depth of 28m up to ground surface, has been inclined 15cm causing large shear stress nearly to the limited state. For the shear stress become 0, the telescopic (a 2m diameter and 30mm thick steel tube) has been placed into the vertical shaft at the middle section, where the shear stress is largest, so that the penstock can work safely while the the rate of sliding placement being 5mm/month.

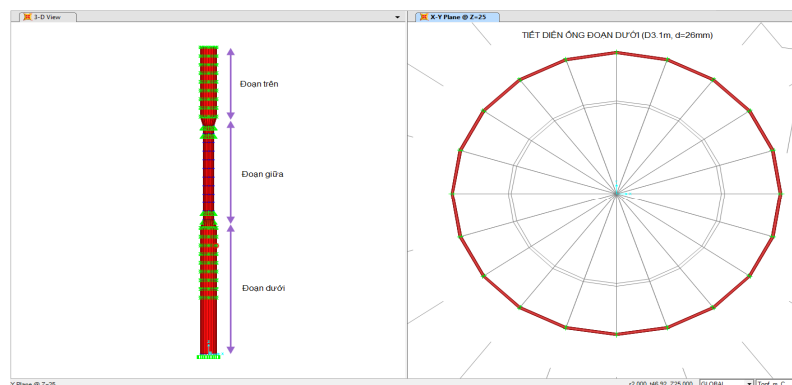
Fig. 11. The telescopic (a 2m diameter, 30mm thick and 26m long steel tube) has been placed in the middle section of penstock
