21 JANUARY 2017

Xekaman 3 hydroelectric plant in Laos: a very major landslide in December

Posted by *Dave Petley* (<https://blogs.agu.org/landslideblog/author/dr-dave/>).

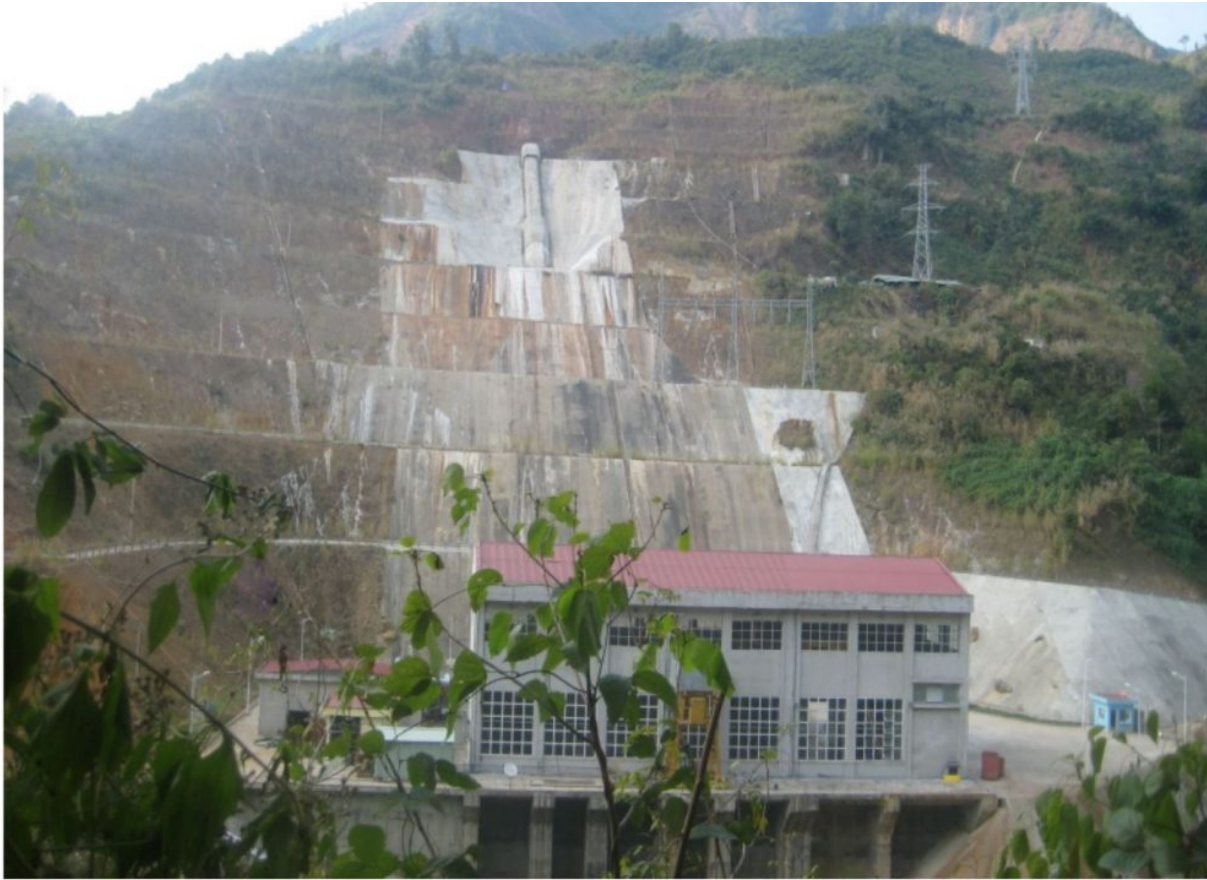
Problems appear to have started soon after the reservoir was filled, and the paper reports multiple movement events, mostly with reasonably small displacements, that caused major damage to the penstock and associated pipelines. At one location it appears that a sinkhole has opened up, and there is also a reference to a new channel being formed. The paper notes that work was ongoing to try to solve the landslide problem; in the meantime a telescopic section of pipe was installed into the pipeline to try to accommodate movement. The paper includes the photograph below of the site. Note the re-engineered walls and structures. Note also the red-roofed powerhouse at the toe of the slope – this is a key structure in the most recent event:

The penstock site for the Xekaman 3 HEP station, via the [ISRM](http://vietrocknet.org/app/webroot/img/files/Vietrock2015%20Proceedings/S064.pdf)
(<http://vietrocknet.org/app/webroot/img/files/Vietrock2015%20Proceedings/S064.pdf>)

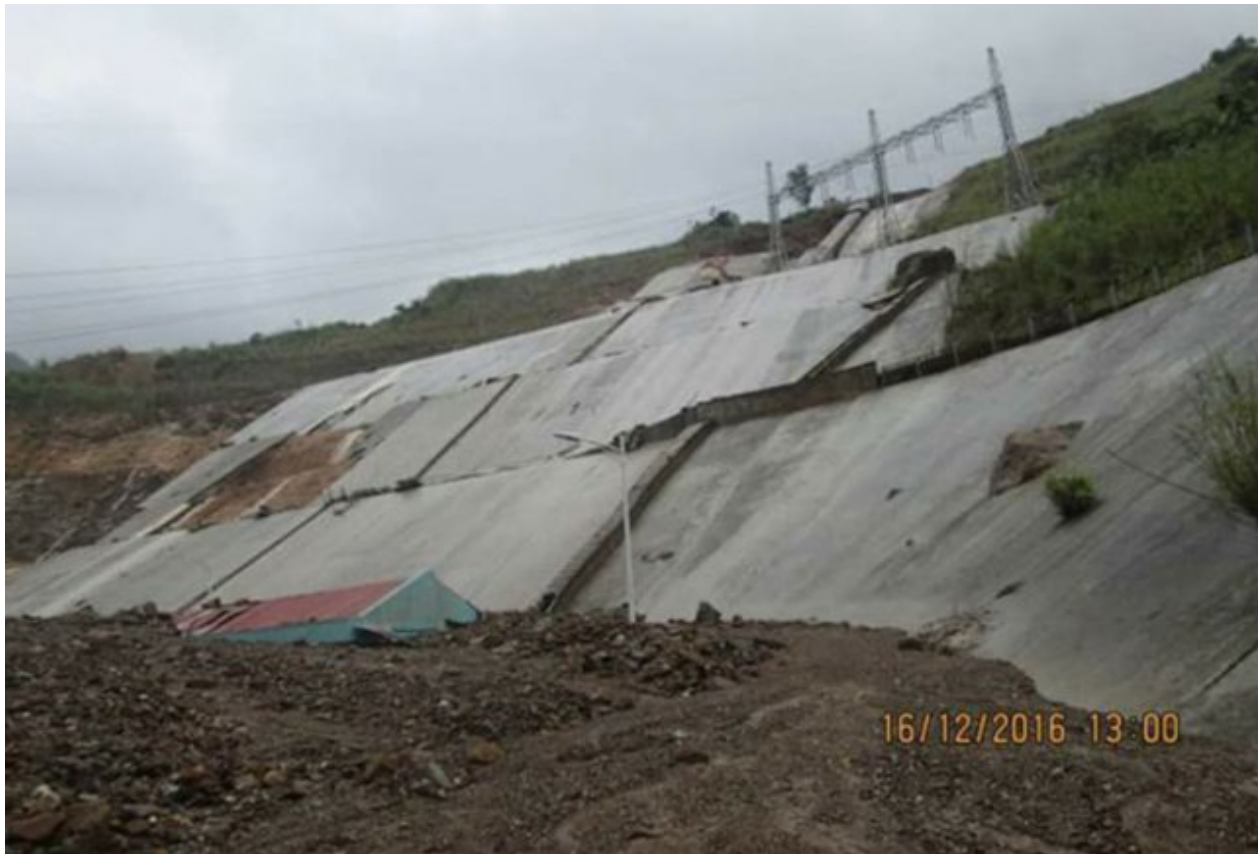
At 8:45 am on 16th December a major failure occurred on this slope, which has destroyed the penstock infrastructure. [Radio Free Asia](http://www.rfa.org/english/news/laos/laos-xekaman-dam-12222016155523.html) has a report (<http://www.rfa.org/english/news/laos/laos-xekaman-dam-12222016155523.html>) about the landslide, which states that:

"The broken portion of the pipe is about 100 meters from the power house," said an official who spoke on condition of anonymity. "Rocks and mud flowed into the power house."

According to the official, the damage is extensive as the power house and its equipment were inundated.

The aftermath of the 16th December landslide at Xekaman 3, via [Radio Free Asia](http://www.rfa.org/english/news/laos/laos-xekaman-dam-12222016155523.html) (<http://www.rfa.org/english/news/laos/laos-xekaman-dam-12222016155523.html>). Photograph by Kamphon

The almost completely buried building is the power house at the toe of the slope. This was clearly an exceptionally serious, and expensive, landslide.
