Xekaman 3 Dam images below:

Xekaman 3 hydroelectric power project is located about 10 km from the border with Vietnam on Nam Pagnou (river), the main tributary of Xekaman river, Dak Cheung district, Sekong province, Lao PDR.

PROBLEM EMERGES - Fairly soon after completion, the dam started to be plagued by landslide problems at the penstock which it appears was constructed on an ancient landslide. Problems started soon after the reservoir was filled as small land displacements caused major damage to the penstock and associated pipelines. At one location it appeared that a sinkhole was opening up and there also may have been a new channel being formed.

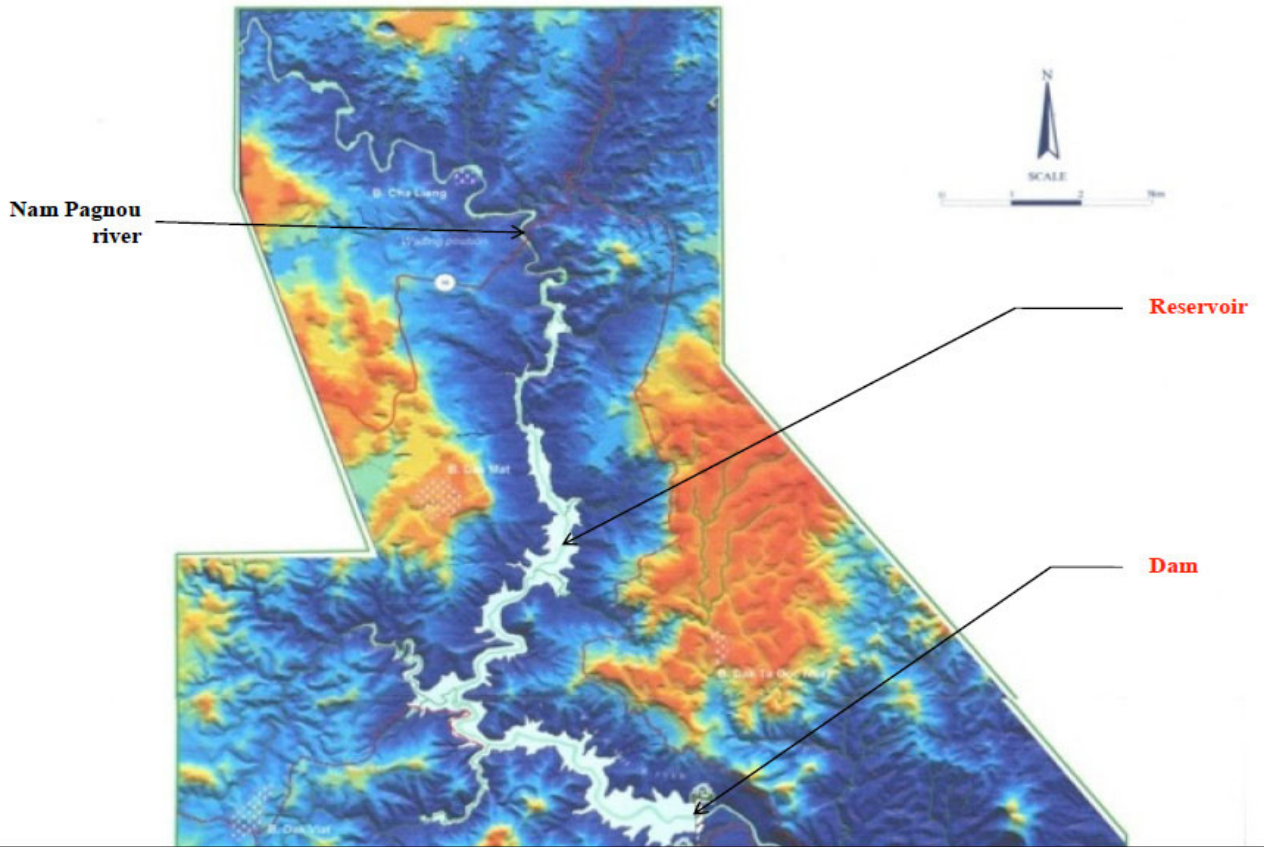
FIGURE 2: SKETCH MAP OF XEKAMAN 3 HYDROELECTRIC SYSTEM
(Water level +960m)

The Xekaman 3 hydropower plant has a 101.5 meter high concrete face rockfill dam, a 6,008 meter long headrace tunnel, a 1,110 meter long penstock and a 520 meter gross head.

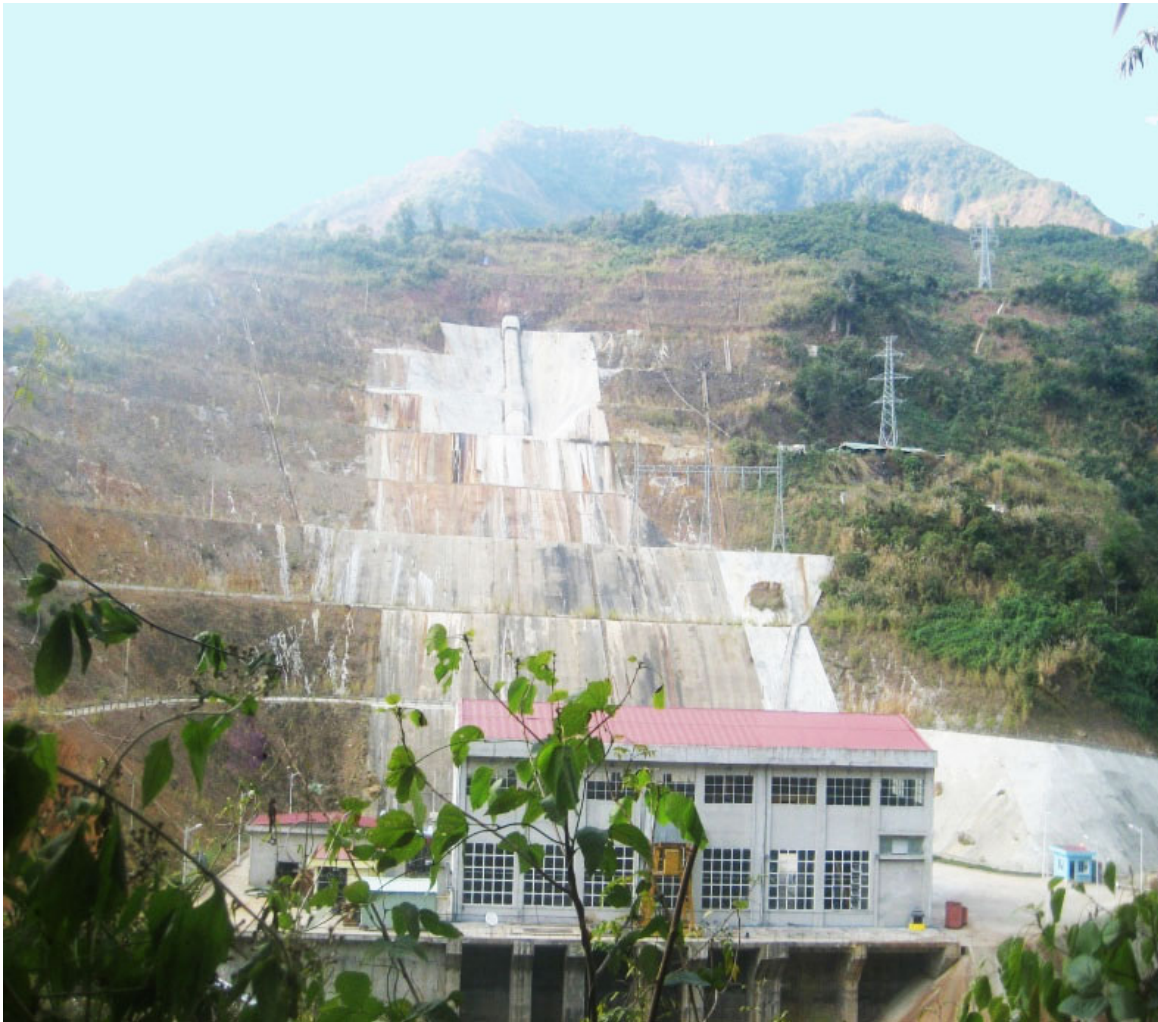
Penstock image below:

Work was ongoing to try to solve the landslide problem. A telescopic section of pipe was installed into the pipeline to try and accommodate the land movement. On 16 December 2016 a major failure occurred on this slope which destroyed the penstock infrastructure. Although the break in the penstock posed no threat to people living downstream, it marked the second breakdown in the tunnel that channels water to the power turbines.

The damage was extensive as the power house and its equipment were inundated. A foreign expert said the penstock may lie on the site of an ancient stabilized landslide, but due to the construction of the cut slope upstream of the power house, the ancient landslide reactivated, creating a rupture of the penstock and an inclination of vertical shaft N2, so electrical generation has been stopped.

Measures for stabilizing the landslide were carried out by removing soil from the head of the landslide, dewatering the cut slope and constructing a concrete shearpile wall. But an expert said it is difficult to stop completely the displacement caused by landslides. One official remarked that in order to generate electricity the short term alternative is "living together with the landslide". Until the problem is fully resolved, the power house may be generating with only one operational unit.
