About the damage of the penstock of Xekaman 3 hydropower plant due to sliding and the remedial measures for power generation

Bui Khoi Hung ^{*a}, Dao Manh Tung ^a

^a*Song Da consulting JSC, Ha Noi, Viet Nam*

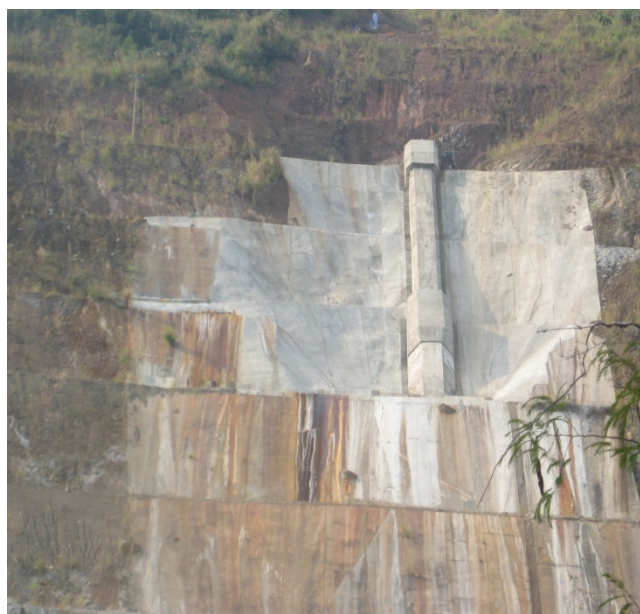
Fig.2: The interval of open penstock (detail)

At the cut slope upstream of the power house, the landslide has happened during the rainy season, destroying the penstock so the electrical generation has been stopped. First the short term alternative of remedial measure was recommended to early generate power, because the owner needs the

money from electricity sales to pay the bank interest and to repair the structure, while continuing to research the design of a long term alternative to ensure the safe operation of power plant.

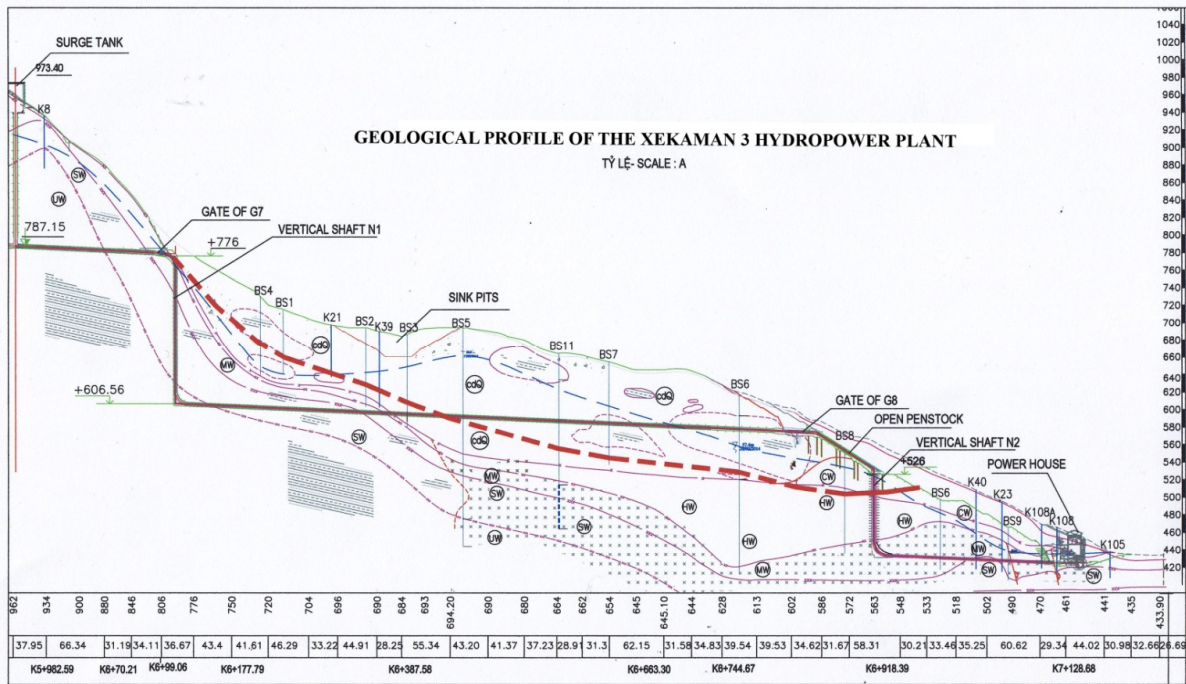
Fig. 4 Geological profile of the Xekaman 3 hydropower project

2.1. At the West and the South of the power house and the Xekaman river channel is the sedimentary rock of the Long Dai formation ($O_3 - S_1$ ld) consisting of sandstone, quartzite bedded, tuf sandstone, tuf siltstone, and is strongly altered due to the penetration of several dykes of quartz and mirodiorite. From the surge tank area to the beginning interval of penstock is composed of the sedimentary rock of Song Bung information (T_{1-2} sb₂), gravellite at the bottom and intercalated sandstone and siltstone at the upper part, the rocks are bedded and rather hard. At the end part of the
