21 JANUARY 2017

Xekaman 3 hydroelectric plant in Laos: a very major landslide in December

Posted by *Dave Petley* (<https://blogs.agu.org/landslideblog/author/dr-dave/>).

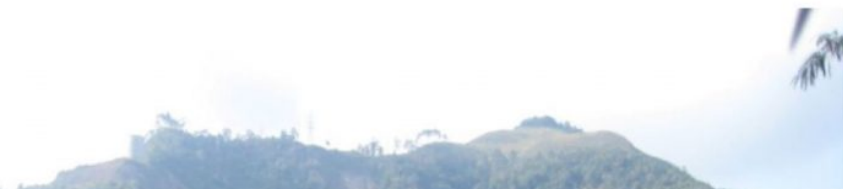
Problems appear to have started soon after the reservoir was filled, and the paper reports multiple movement events, mostly with reasonably small displacements, that caused major damage to the penstock and associated pipelines. At one location it appears that a sinkhole has opened up, and there is also a reference to a new channel being formed. The paper notes that work was ongoing to try to solve the landslide problem; in the meantime a telescopic section of pipe was installed into the pipeline to try to accommodate movement. The paper includes the photograph below of the site. Note the re-engineered walls and structures. Note also the red-roofed powerhouse at the toe of the slope – this is a key structure in the most recent event:

The penstock site for the Xekaman 3 HEP station, via the [ISRM](http://vietrocknet.org/app/webroot/img/files/Vietrock2015%20Proceedings/S064.pdf)
(<http://vietrocknet.org/app/webroot/img/files/Vietrock2015%20Proceedings/S064.pdf>)
