Xekaman 3 hydroelectric plant in Laos: a very major landslide in December (<https://blogs.agu.org/landslideblog/2017/01/21/xekaman-3/>)

Xekaman 3 hydroelectric plant in Laos: a very major landslide in December

The Xekaman 3 hydroelectric power station (<https://cdm.unfccc.int/Projects/DB/SQS1324398658.36/view>) in Laos is a 250 MW dam, tunnel and associated infrastructure located at 15.375N 107.407E, close to the border with Vietnam. Built between 2006 and 2010 at a cost of US\$273 million, 90% of the electricity generated is exported to Vietnam. Fairly soon after completion the dam started to be plagued by landslide problems, not at the dam site but at the penstock, which it appears was constructed on an ancient landslide without adequate measures being taken to provide stability. There is a nice paper providing details of the landslide affecting the Xekaman 3 penstock online here (<http://vietrocknet.org/app/webroot/img/files/Vietrock2015%20Proceedings/S064.pdf>) (NB this is a PDF).

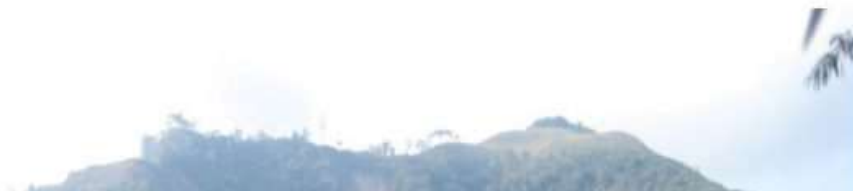
Problems appear to have started soon after the reservoir was filled, and the paper reports multiple movement events, mostly with reasonably small displacements, that caused major damage to the penstock and associated pipelines. At one location it appears that a sinkhole has opened up, and there is also a reference to a new channel being formed. The paper notes that work was ongoing to try to solve the landslide problem; in the meantime a telescopic section of pipe was installed into the pipeline to try to accommodate movement. The paper includes the photograph below of the site. Note the re-engineered walls and structures. Note also the red-roofed powerhouse at the toe of the slope – this is a key structure in the most recent event:

The penstock site for the Xekaman 3 HEP station, via the [ISRM](http://vietrocknet.org/app/webroot/img/files/Vietrock2015%20Proceedings/S064.pdf)
(<http://vietrocknet.org/app/webroot/img/files/Vietrock2015%20Proceedings/S064.pdf>)

At 8:45 am on 16th December a major failure occurred on this slope, which has destroyed the penstock infrastructure. [Radio Free Asia has a report](http://www.rfa.org/english/news/laos/laos-xekaman-dam-12222016155523.html) (<http://www.rfa.org/english/news/laos/laos-xekaman-dam-12222016155523.html>), about the landslide, which states that:

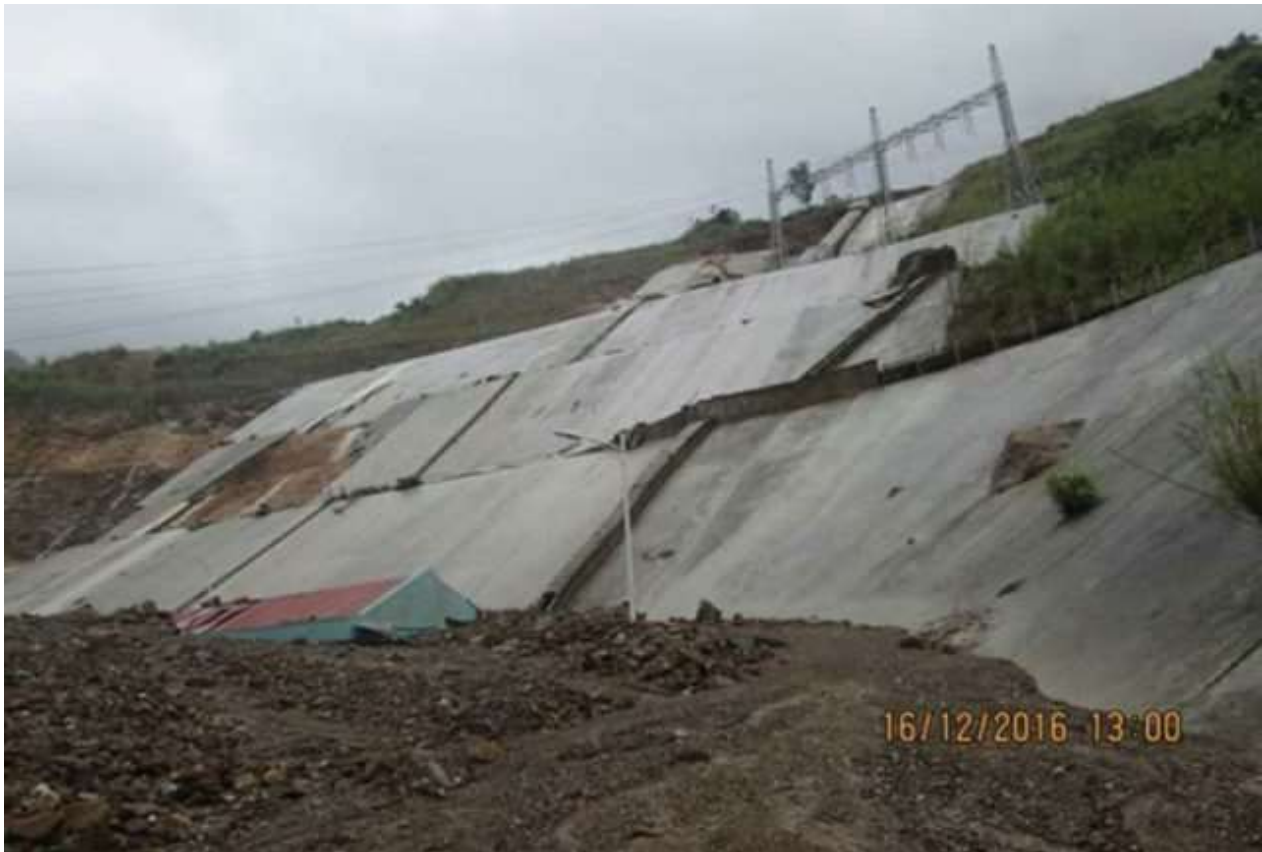
"The broken portion of the pipe is about 100 meters from the power house," said an official who spoke on condition of anonymity. "Rocks and mud flowed into the power house."

According to the official, the damage is extensive as the power house and its equipment were inundated.

The aftermath of the 16th December landslide at Xekaman 3, via [Radio Free Asia](http://www.rfa.org/english/news/laos/laos-xekaman-dam-1222016155523.html) (<http://www.rfa.org/english/news/laos/laos-xekaman-dam-1222016155523.html>). Photograph by Kamphon

The almost completely buried building is the power house at the toe of the slope. This was clearly an exceptionally serious, and expensive, landslide.
